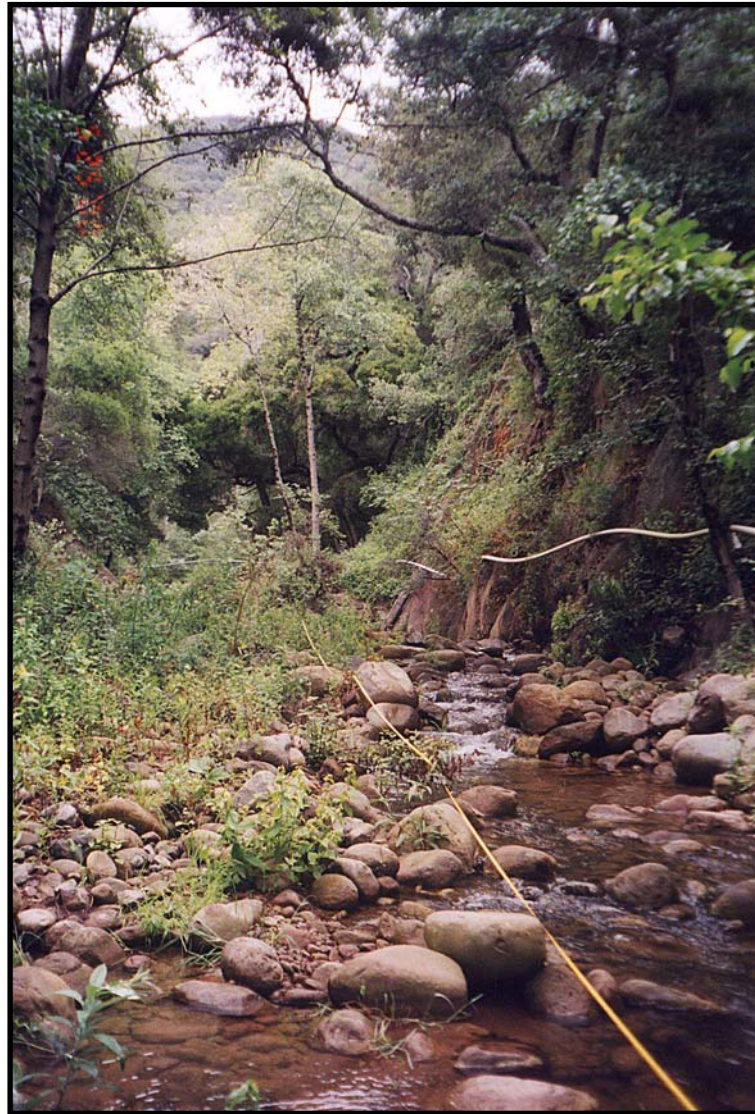
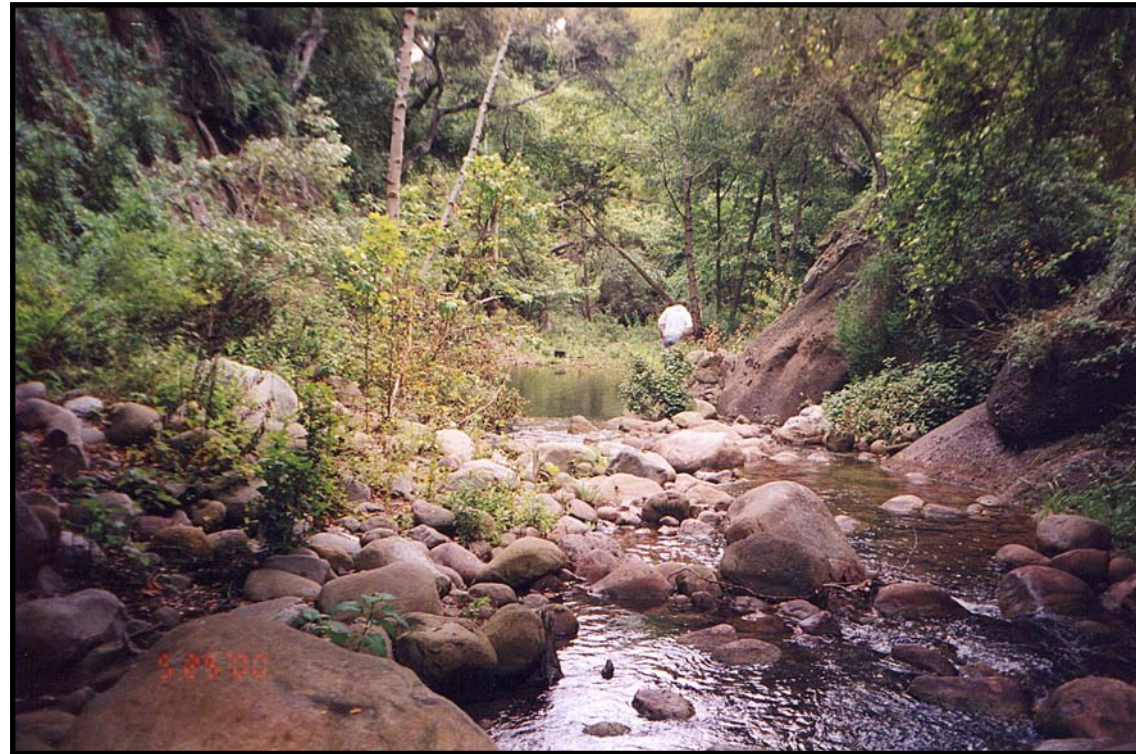
Photographs of Gobernador Creek, Study Reach CC-3 (See Figure 1-2 for location). Notice that bedrock sections and medium to large boulders dominate the stream channel. There are also deposits and bars consisting of small boulders, cobble, gravel, and sand. There are alternating sections of riffles and pools. The pool shown in the photograph to the far right is approximately 30 feet in diameter and 6 feet deep. The riparian vegetation is dense, and consists mostly of native species. Dominant riparian trees include white alder, western sycamore, coast live oak, and arroyo willow.
