PHOTOGRAPHS OF REPRESENTATIVE STREAM REACHES

FIGURE 2-7

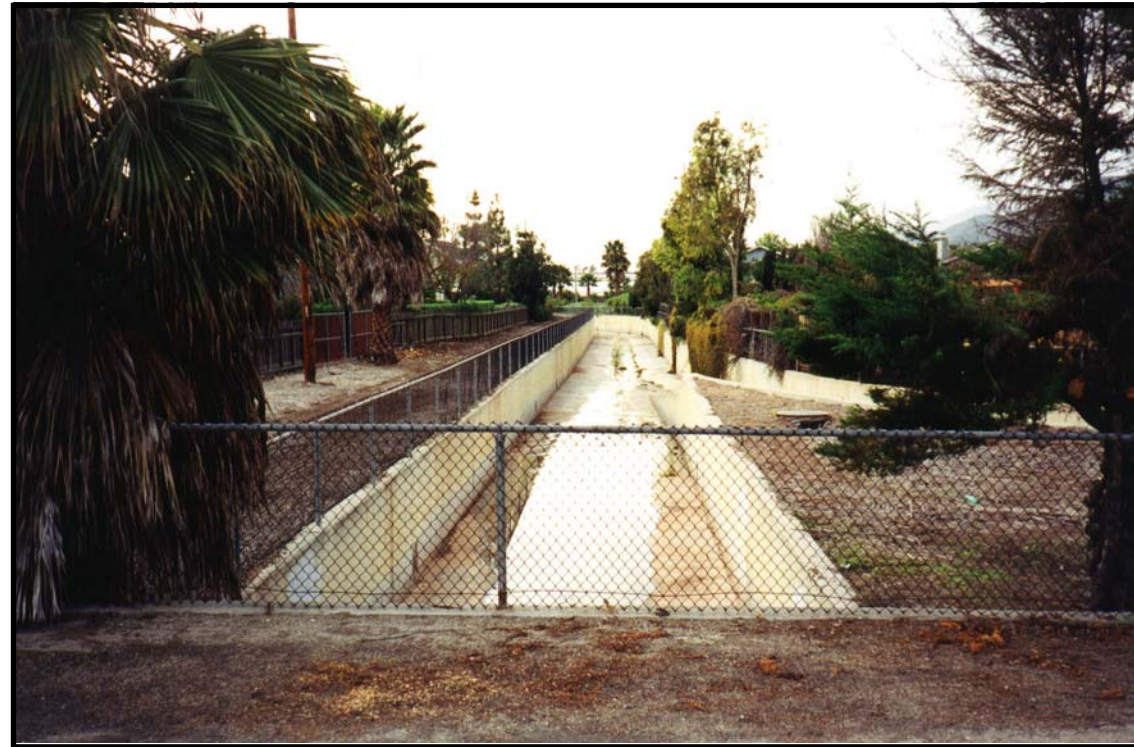
Looking west along the Main Channel of Franklin Creek, from near the Foothill Rd. / Linden Ave. intersection. The West Branch of Franklin Creek enters the Main Channel in the mid-ground of the photograph. These formerly natural creeks have been converted to concrete box channels.

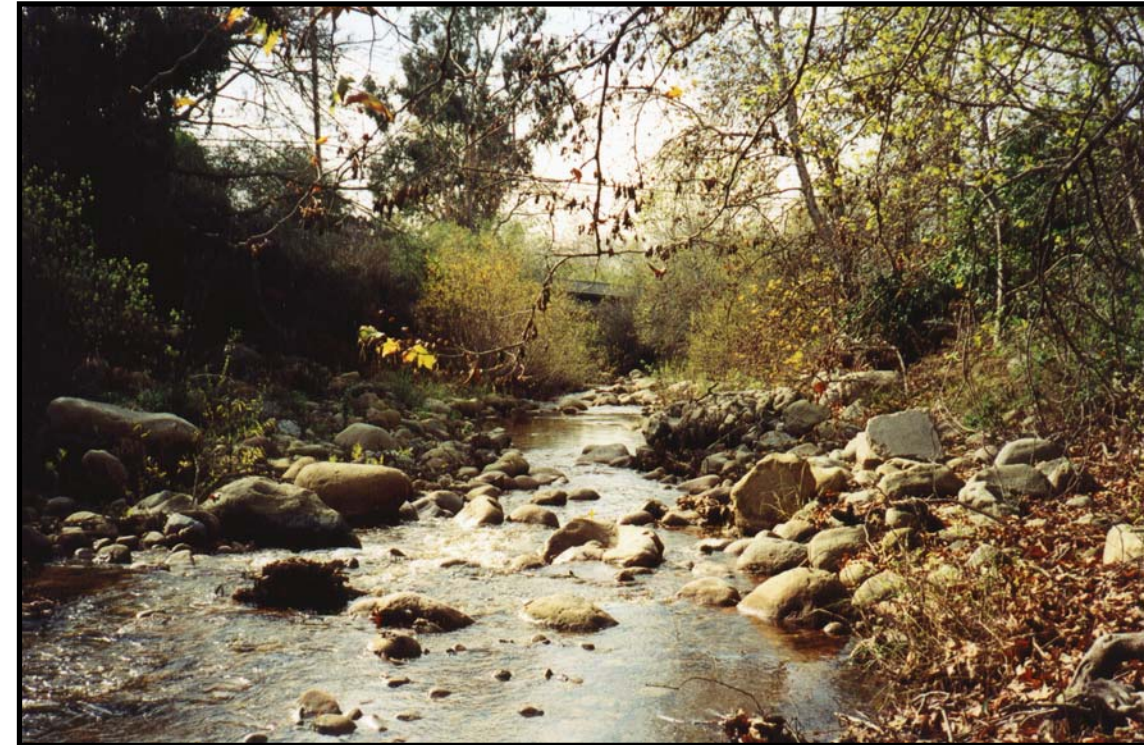
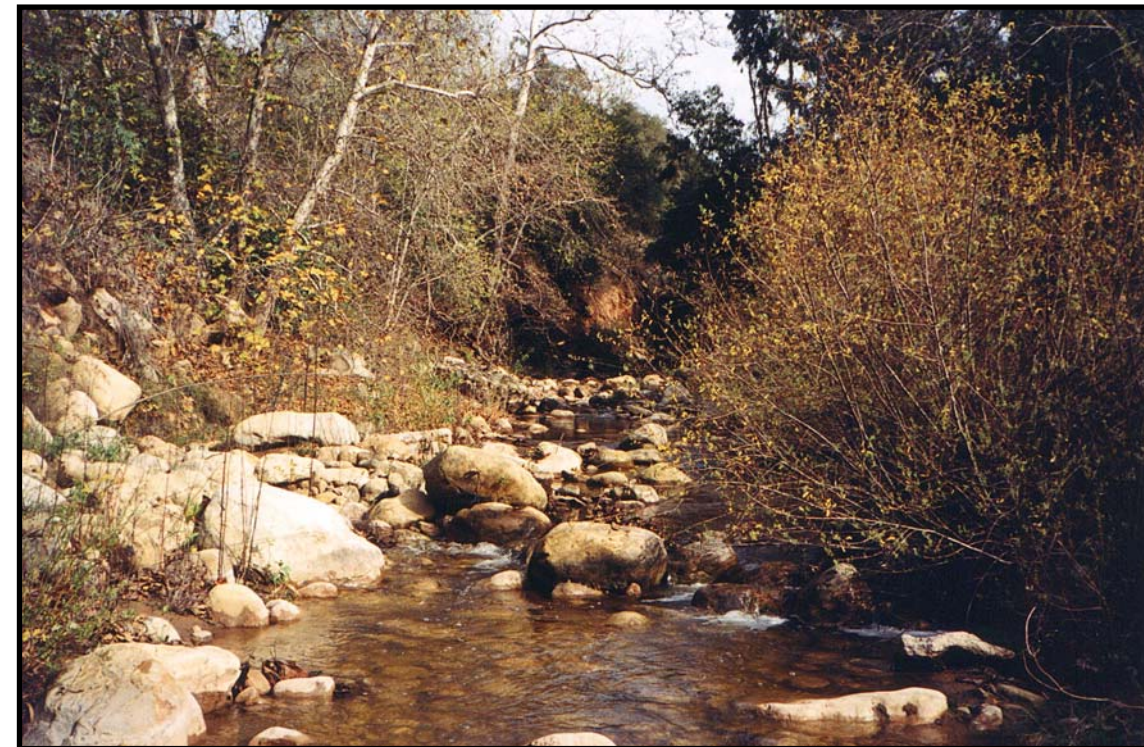
Photographs of lower Carpinteria Creek (above) and Gobernador Creek (below), near the confluence of upper Carpinteria Creek and Gobernador Creek (approximately 150-160 ft. elevation). These stream sections are low to medium gradient, and maintain a bed composed of medium to small sized boulders, and deposits of cobble, gravel, and sand. These stream sections have alternating riffles and pools of shallow to medium depth, and fairly low, gently sloping banks composed of alluvial material and topsoil. A narrow corridor of riparian vegetation is present. Dominant riparian trees are California sycamore, black cottonwood, arroyo willow, and coast live oak.
